## Vibration Stress Testing Report

This report presents the results of a systematic stress test conducted on standard Luxonis devices. The purpose of this test was to assess the performance parameters of focus, stereo depth, and camera angles under controlled conditions before and after conducting the vibration test according to **EN 60068-2-6:2008** standard.

Tests were conducted on three cameras, OAK-D-PoE, OAK-D-Pro-PoE and OAK-D-Pro.

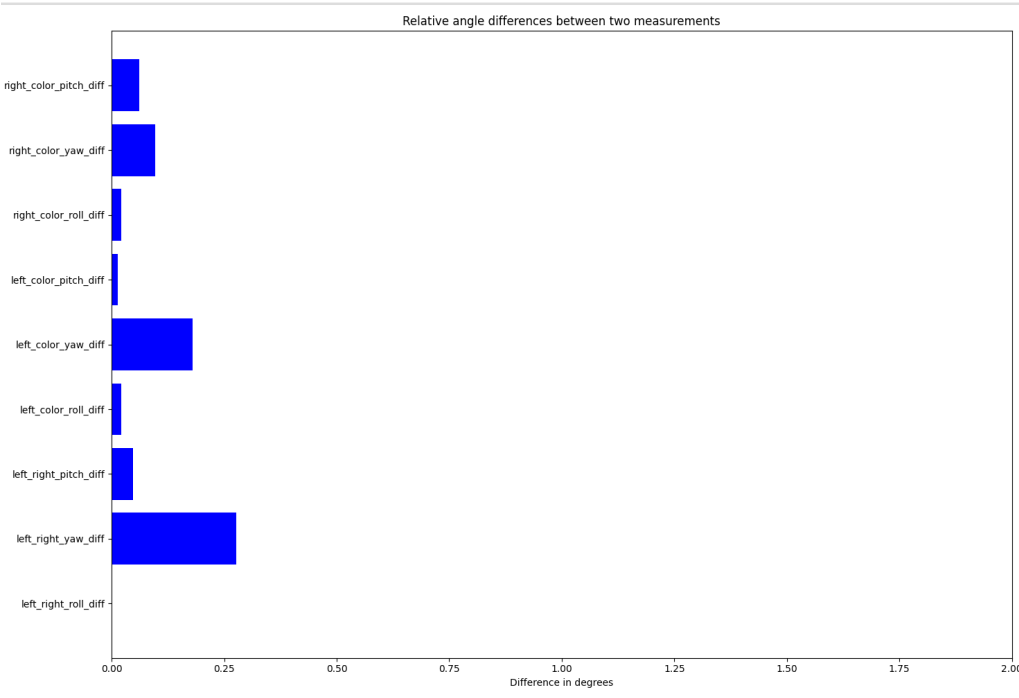
OAK-D-PoE

In successive tests, all three cameras showed differences that were as low as when comparing a single unit twice with no tests being run in between. This suggests that the sensors did not undergo significant movement relative to each other within the detectable limits of the test.

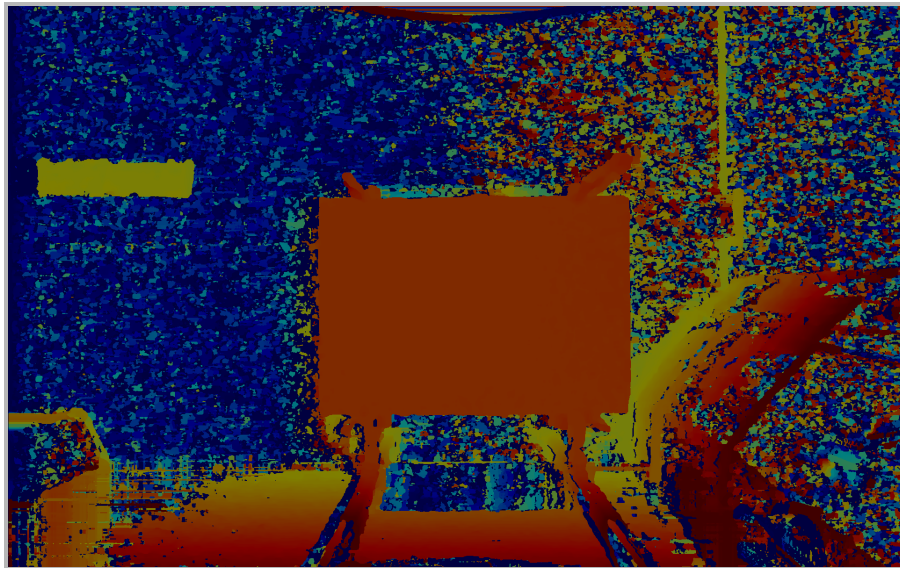
Z accuracy: **-1.45%** of GT (avg distance: 984.52mm)

Spatial noise: 15.74 mm

Depth after vibration testing

All cameras have **little to no depth degradation** after being subjected to the vibration tests detectable by our testing method.

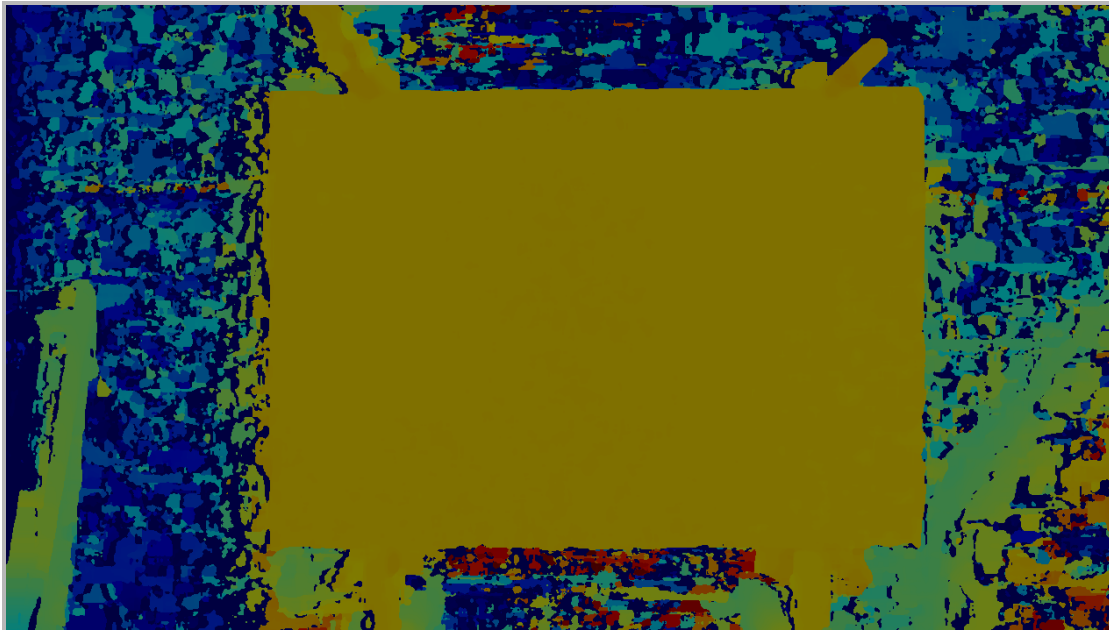
Z accuracy: 4.06% of GT (avg distance: 1041.72mm)

Spatial noise: 41.71 mm

Depth before vibration testing

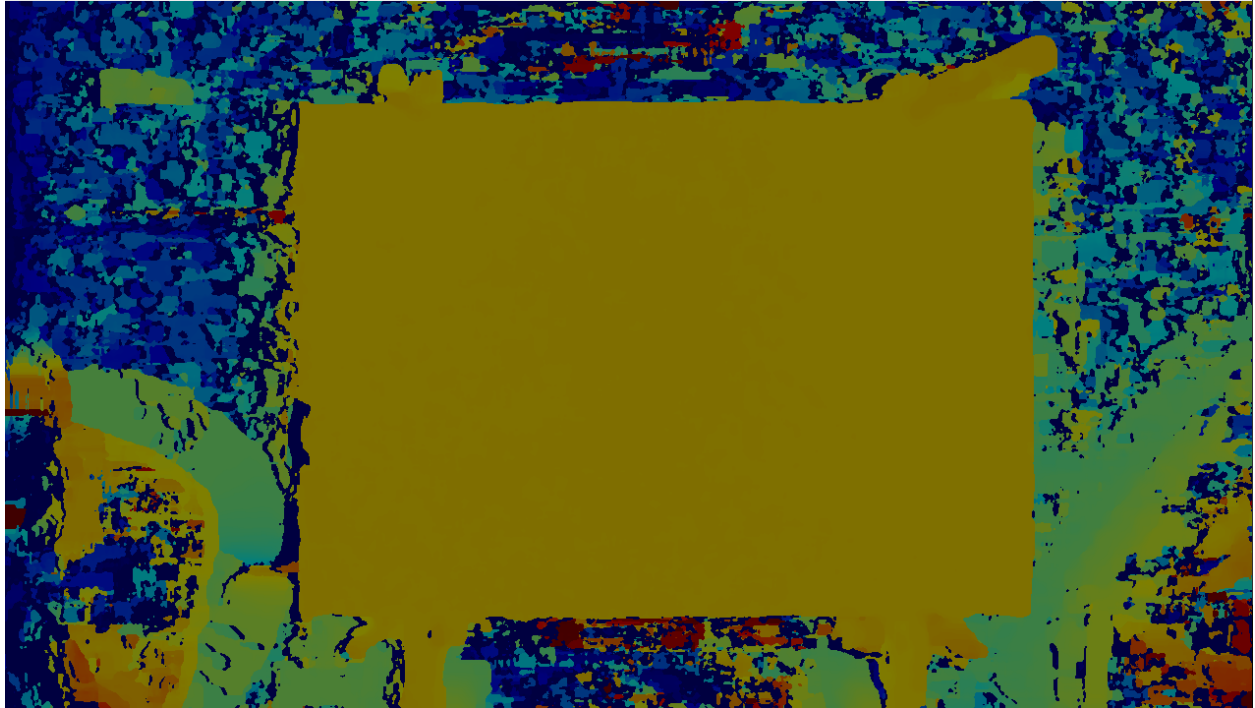
Z accuracy: 4.06% of GT (avg distance: 1040.17mm)

Spatial noise: 40.19 mm

Depth after vibration testing
