## Vibration Stress Testing Report

This report presents the results of a systematic stress test conducted on standard Luxonis devices. The purpose of this test was to assess the performance parameters of focus, stereo depth, and camera angles under controlled conditions before and after conducting the vibration test according to **EN 60068-2-6:2008** standard.

Tests were conducted on three cameras, OAK-D-PoE, OAK-D-Pro-PoE and OAK-D-Pro.

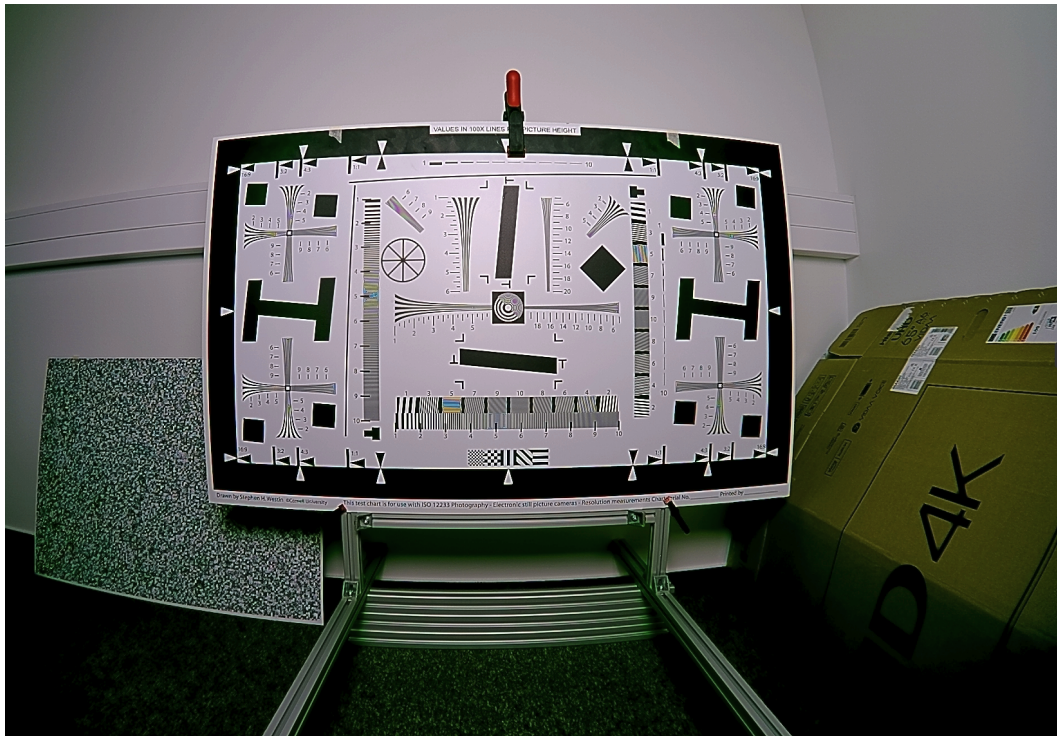
Above is an example picture of the focus board capture.

**No cameras had no visible degradation in the focus of the lenses after being in the vibration chamber.**

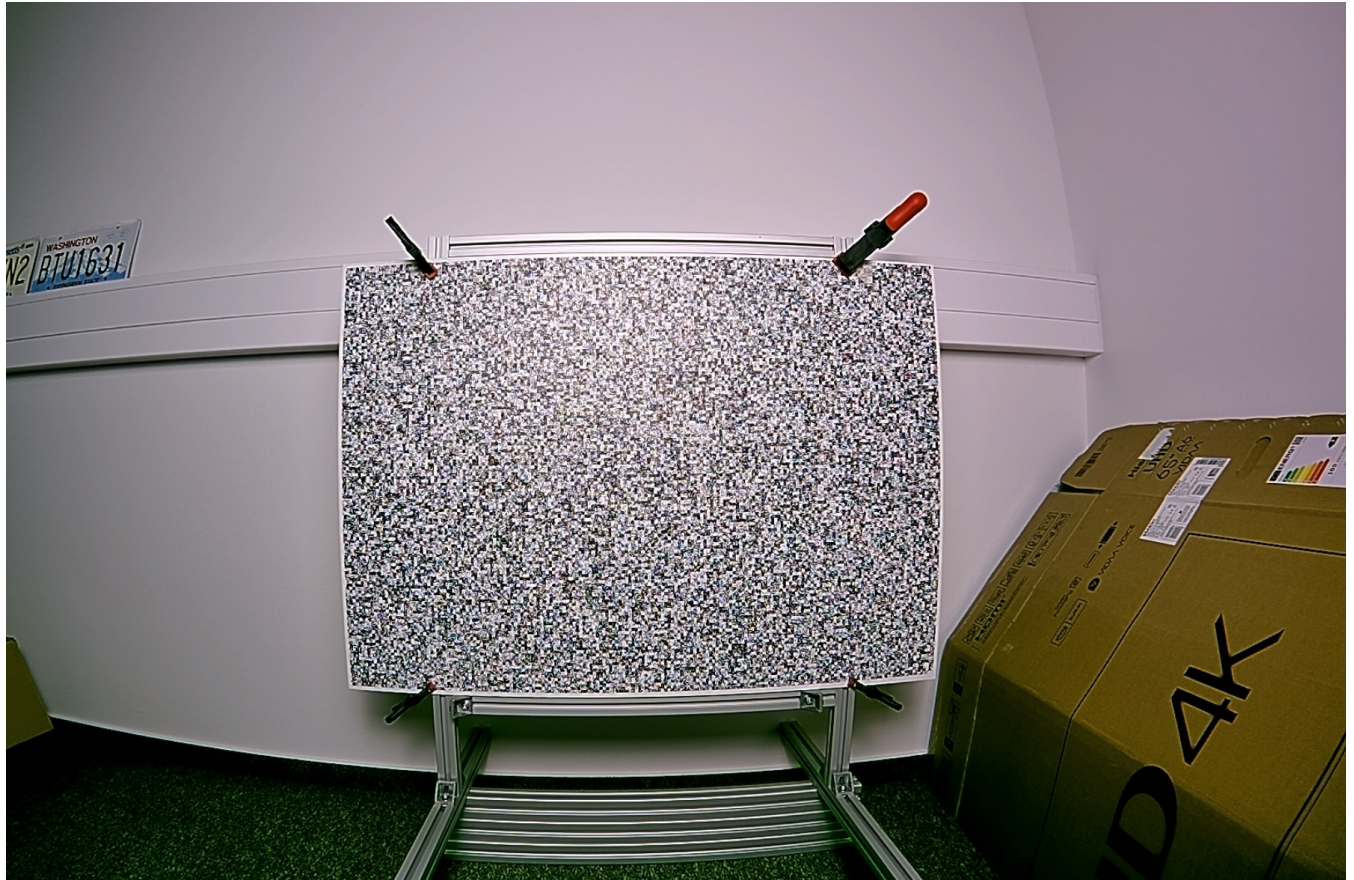
The purpose of depth testing was to check if the depth degraded after the cameras were tested on the vibration desk. It was done on a noise pattern that was mounted in front of the camera .

All cameras have **little to no depth degradation** after being subjected to the vibration tests detectable by our testing method.
